# Manhole Inspection Summary

Manhole # S04YY1019MH

Insp Date: **7/5/06 12:20 PM**

**Location** Address: **3805 BANCROFT RD**

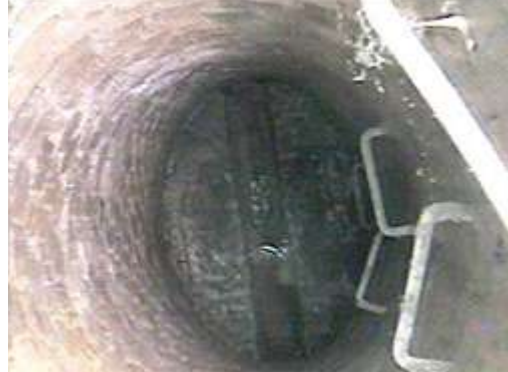
Top View

Adjustment and Corbel infiltration.  
Evidence of surcharge - Bench debris.  
Channel debris.

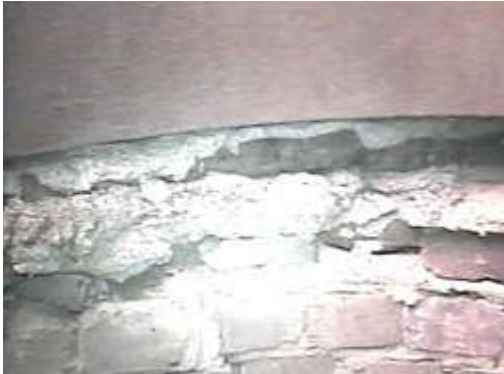
Defect

Frame leaks. Adjustment deterioration,  
loose brick, and infiltration.

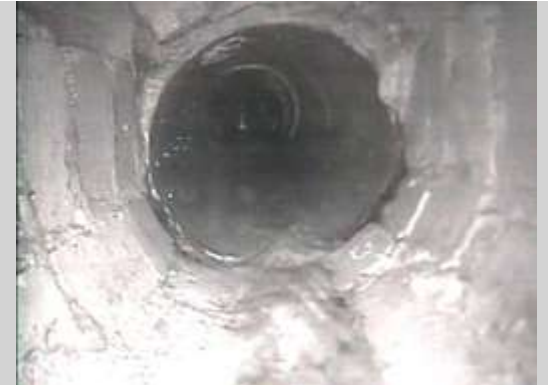
### 8 in. Circular Gravity Sewer Pipe Out @ 12 O'Clock

Comments **The O12 pipe picture shows grease deposits in the Channel. The I6 pipe seal is not flush to the pipe.**

Infiltration: **Evidence** Pipe Seal Cond: **Cracked**

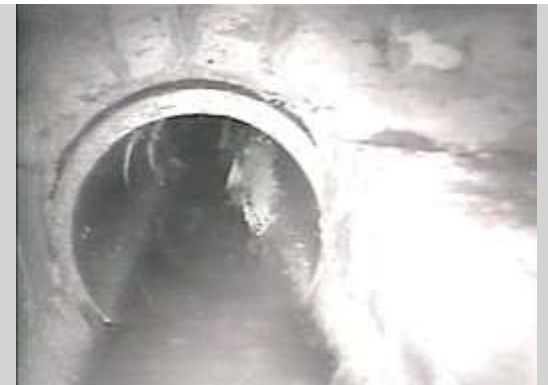
### 8 in. Circular Gravity Sewer Pipe In @ 6 O'Clock

Deposits: ☐ None ☐ Mud ☐ Sludge ☐ Debris ☒ Grease

Silt Depth: **0** (in.) Deposits Extent: **Light**

Infiltration: **Evidence** Pipe Seal Cond: **Unknown**
